Technical Evaluation of the Gold King Mine Incident

San Juan County, Colorado

U.S. Department of the Interior
Bureau of Reclamation
Technical Service Center
Denver, Colorado

October 2015

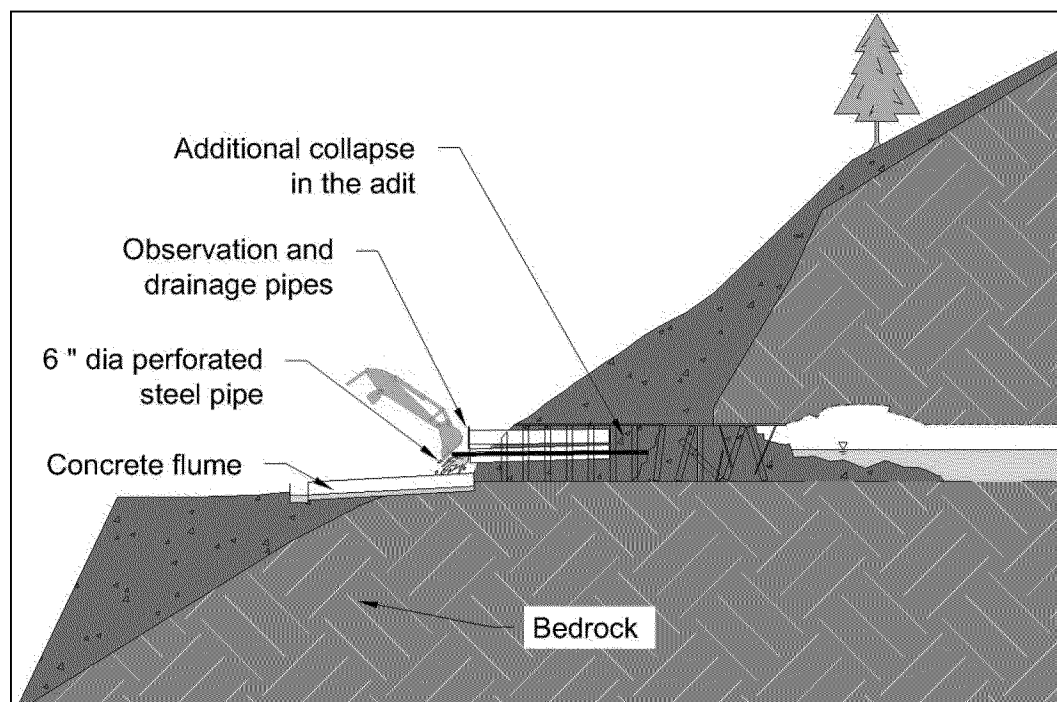
The DRMS stated in the project summary, “A future project at the site may attempt to cooperatively open the Level 7 Old Portal in an effort to alleviate the potential for an unstable increase in mine pool head within the Gold King workings.” Essentially, the closure did not provide adequate drainage and had the potential to blowout.

Figure 21.—Cross-section showing the installation of pipes by DRMS at the Gold King Mine Level 7 New Adit in 2009 (water level as assumed by DRMS) (not to scale).
